## SR 119 Concrete Overlay

### Construction Overview

February 2011

Thomas Boyle  
Project Manager  
Engineering District 12-0

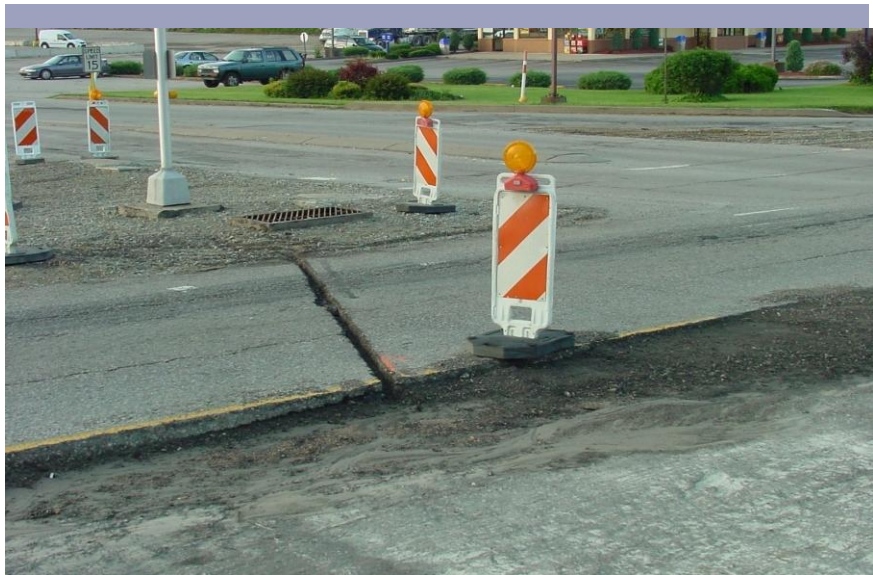
## Drainage slot across travel lane

- Drainage of Phase 1 sag vertical curves
  - Resulted from trapped water against 4 ½" pvt edge
  - Concerned with night-time off-peak hours of travel
  - "Vermeer cut" trenches across travel lanes at specific locations

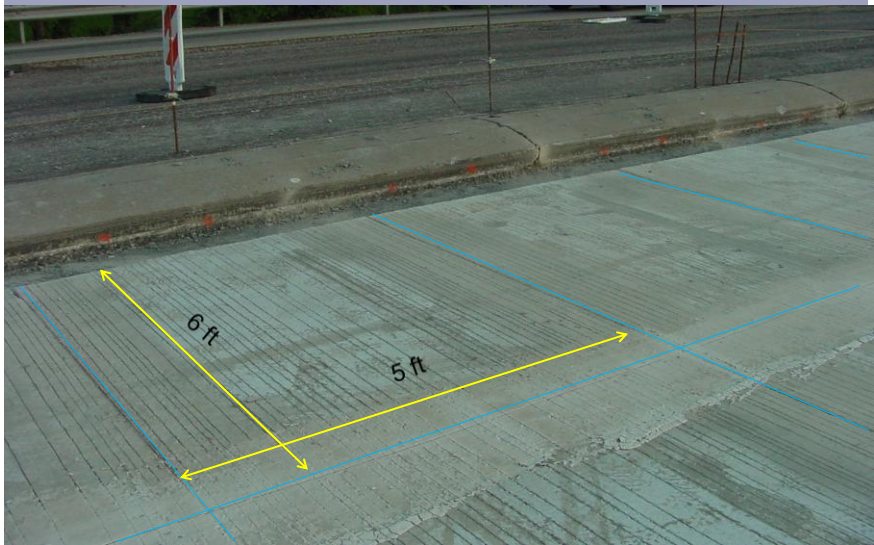
**Lateral joint spacing to match curb joints**

- Mountable curb issues
  - Cost and condition
  - Less than desirable longitudinal joint spacing
  - Lateral inlet adjustments
  - Revised lateral joint spacing

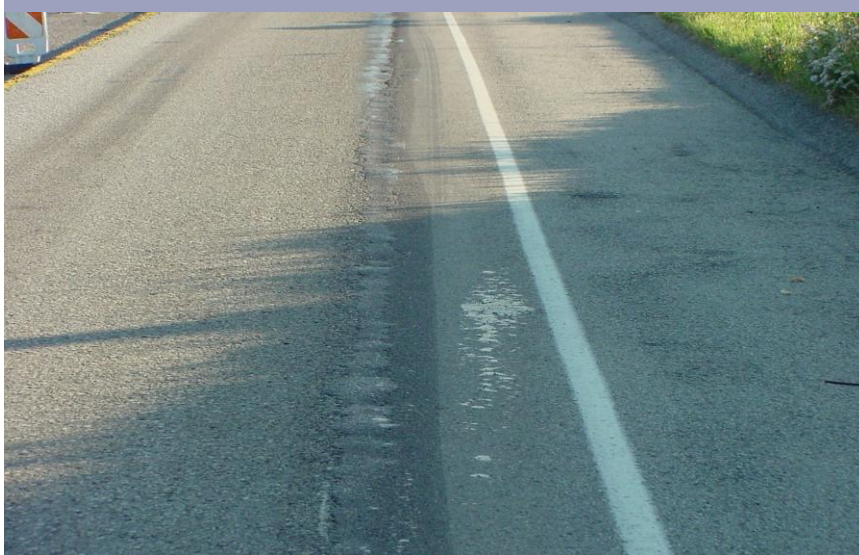
## Unraveled shoulder joint

- Shoulder edge failure
  - Traffic on joint for Phase 1 caused deterioration
  - Effect on Phase 2 concrete placement
  - Additional width of travel lane concrete
