6100 HRA tie-in to existing HRA membrane system

Shown: horizontal tie-in to vertical transition

Detail>> D-1015-1A

Drawing No.
D-1015-1C

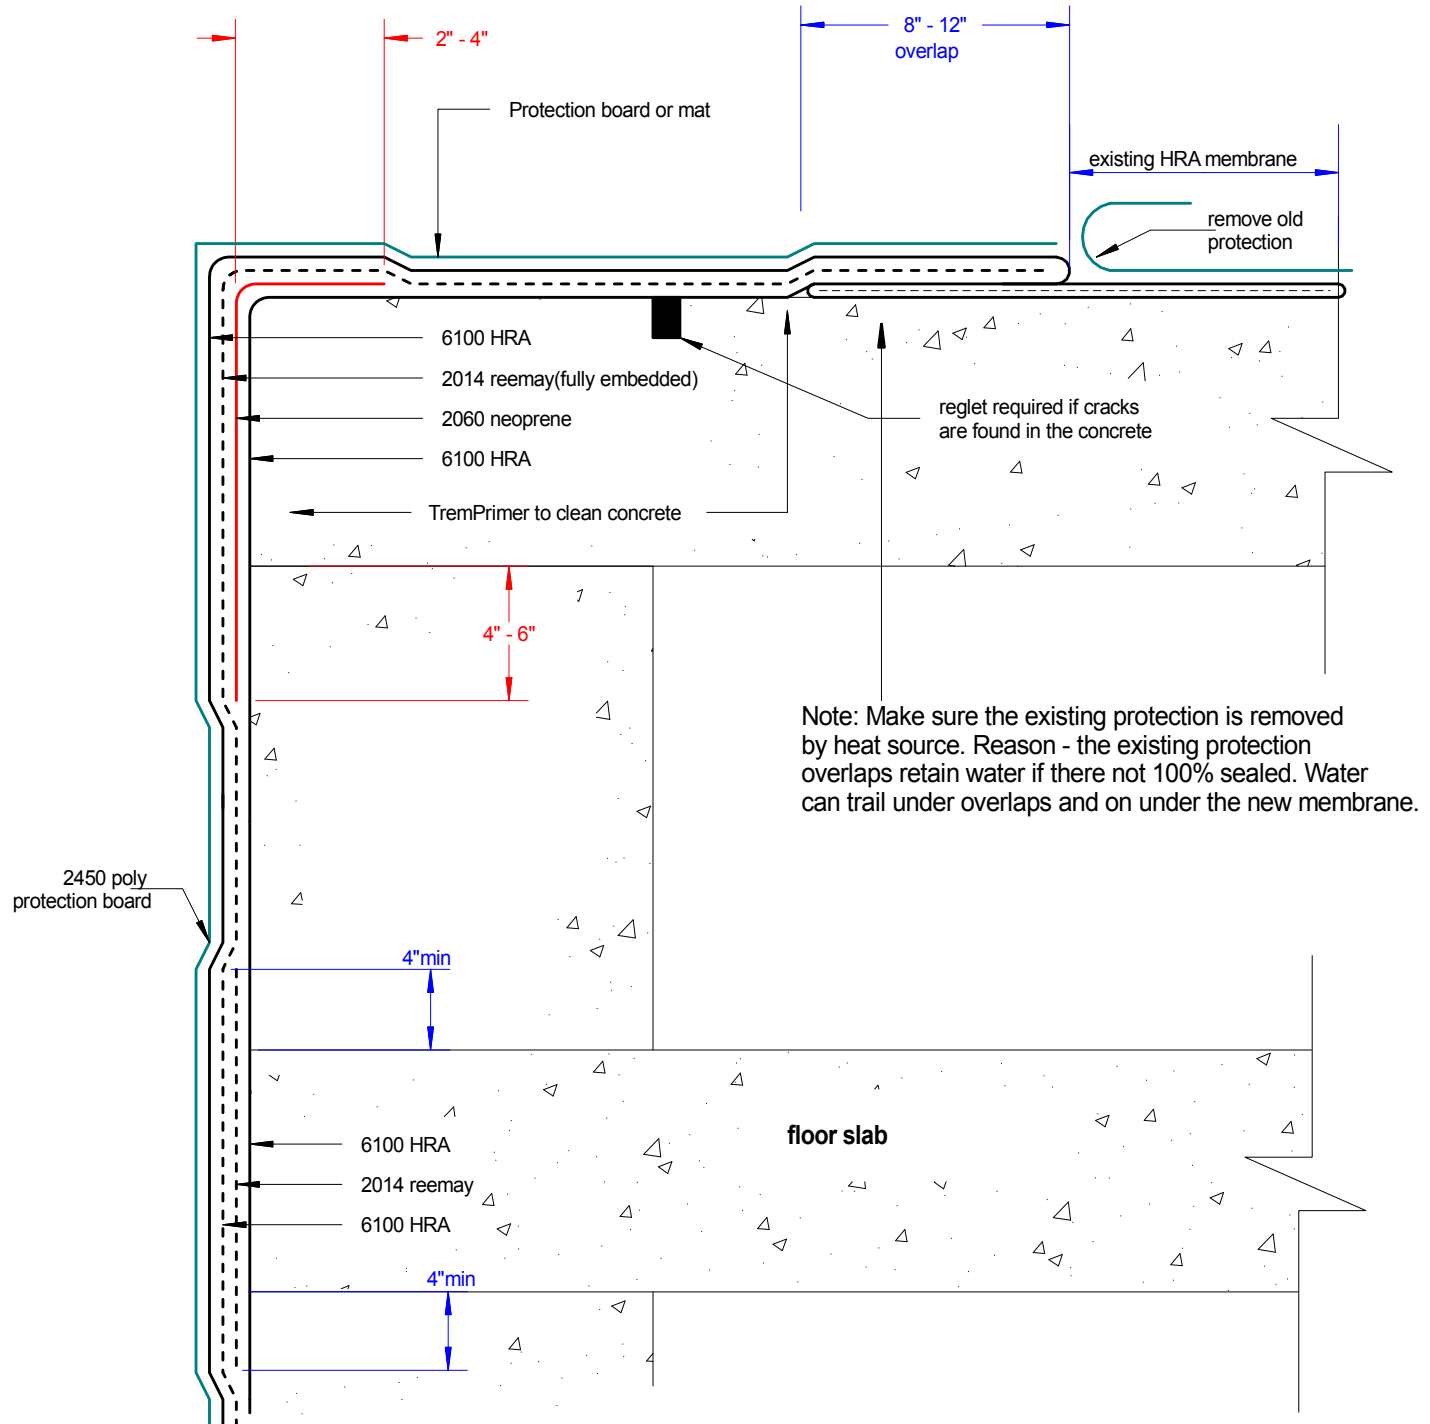
6100 HRA tie-in to existing HRA membrane system
Shown: horizontal tie-in to vertical transition

Note: Make sure the existing protection is removed by heat source. Reason - the existing protection overlaps retain water if there not 100% sealed. Water can trail under overlaps and on under the new membrane.
